**Assessment of Retrofit Feasibility
Of Selected Storm Water Systems
In Brush Neck Cove Watershed**

Warwick, RI

**Report Prepared by
Southern Rhode Island Conservation District
In partial fulfillment of the
Greenwich Bay Storm Water Management Project
(Contract 99-Water (NPS)-12)**

October 2002

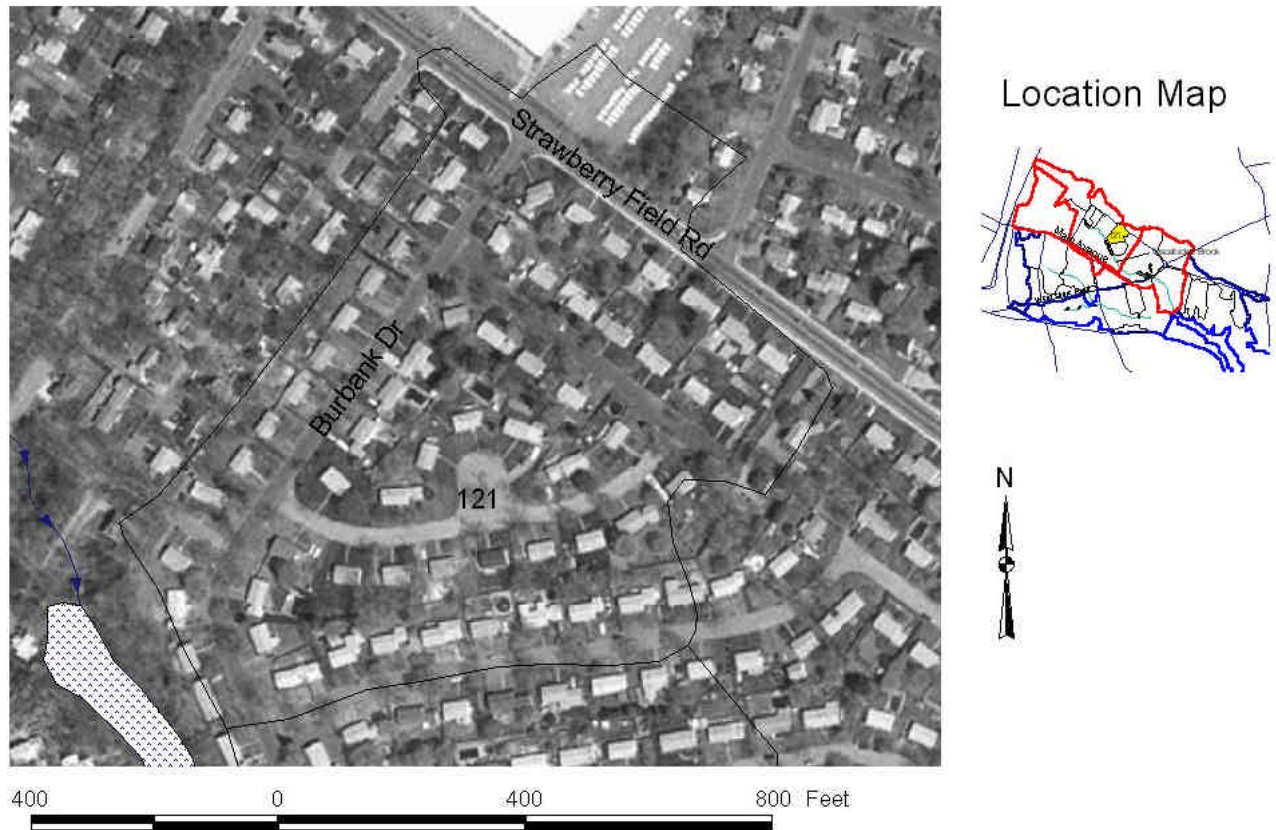
Figure 14. Upper Tuscatucket Subwatershed System 121

It appears that years of sediment have built up at the outfall to create a diversion, so flows now travel an additional 100 feet or so before entering the pond. While it may be possible to enhance conditions at the outfall, it is not considered feasible due to limited access and ownership issues. In-line innovative storm water treatment technologies could be used to capture sediments, oils and greases. A soils investigation would be needed to determine the feasibility of infiltration structures placed throughout the catchment.

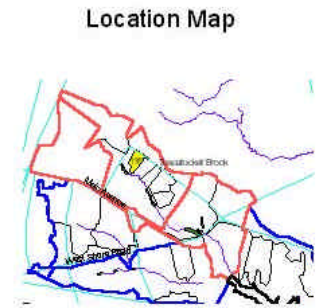
Figure 15. Upper Tuscatucket Subwatershed System 116

Limited room and access make outfall renovations unfeasible. In-line innovative storm water treatment technologies could be used to capture sediments, oils and greases. A soils investigation would be needed to determine the feasibility of infiltration structures placed throughout the catchment. According to the RI Airport Corporation (J. Zisiades, October 2000), some houses on the west side of the drainage area may be removed, which should reduce availability of pollutants and increase infiltration.

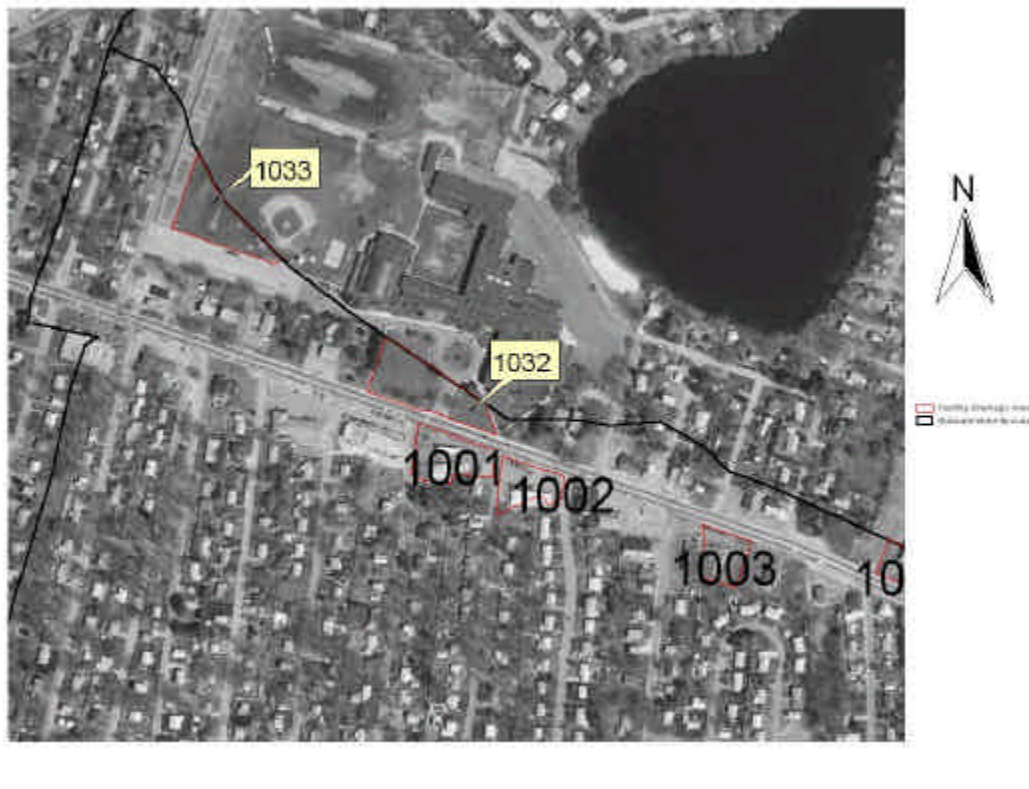
Figure 17. Facilities (Permanent Open Spaces) at Veteran’s Memorial High School

In reviewing the systems and database, some existing and proposed permanently protected open spaces were noted within some systems. Further reflection led to adding these areas as facilities that provide some treatment, since they are in low-intensity land uses. Facilities #1032 and #1033 are the front yard and portion of a ball field of the Veteran’s Memorial High School (Figure 17). Facilities # 1034 through #1042 are portions of Airport property that are maintained as meadow (Figures 18 and 19). Facilities #1043 through #1045 are areas that the RI Airport Corporation indicated as new buy-out areas (J. Zisiades, October 2000); the map of these areas is not available to the public at this time.
